AFRPL-TR-75-62

STORABILITY INVESTIGATIONS OF WATER
LONG-TERM STORAGE EVALUATION
SECOND ANNUAL REPORT

AEROJET LIQUID ROCKET COMPANY
SACRAMENTO, CALIFORNIA

DECEMBER 1975

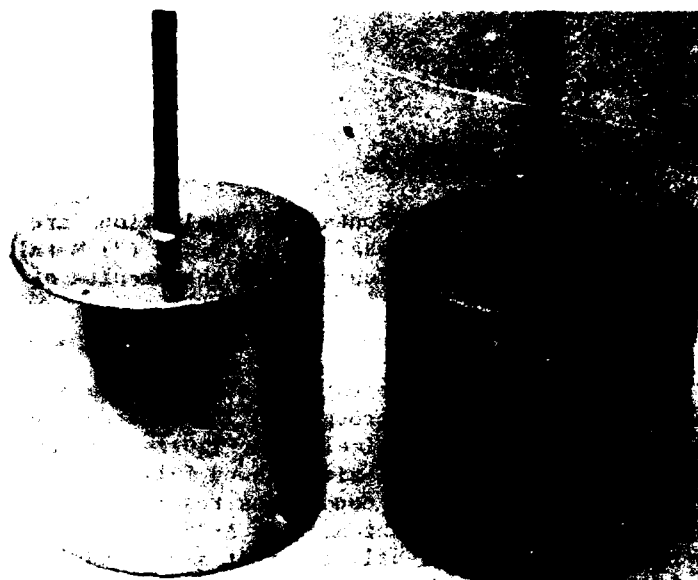
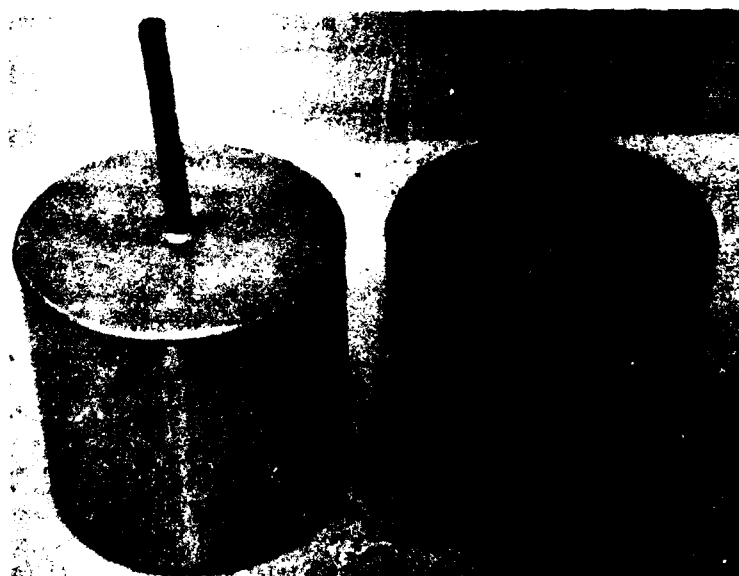
Figure 1. 304 Stainless Steel Containers, Magnification 1/3X

No discrepancies were found in the 304 stainless steel containers. One of the containers, No. 2, had a darker appearance than the remaining containers. This condition is attributable to inadequate hydrogen gas coverage in the tank during annealing after welding. The weld contaminants reported in the examination of the six and twelve month exposure tanks were not found in this examination.

The external appearance of the containers is documented photographically in Figures 1 through 5. The internal appearance of the containers is documented photographically in Figures 6 through 15. Examination of these surfaces without visual aids showed full penetration for the full length of all weldments. Other conditions resulting from fabrication and cleaning procedures were: (1) etching of A-286 containers during pickling; (2) isolated dark areas, a tightly adherent smut, and isolated shiny deposits of material in one of the 17-4PH stainless steel containers; (3) a tightly adherent smut in the Inconel 718 containers; and (4) isolated areas of residual titanium oxide, localized circular areas of attack, and a general mottled appearance including fingerprint contamination in the 6Al-4V titanium containers.

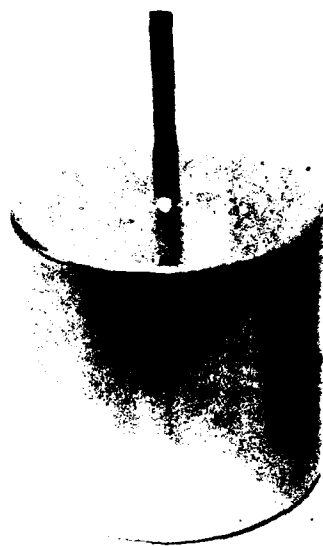
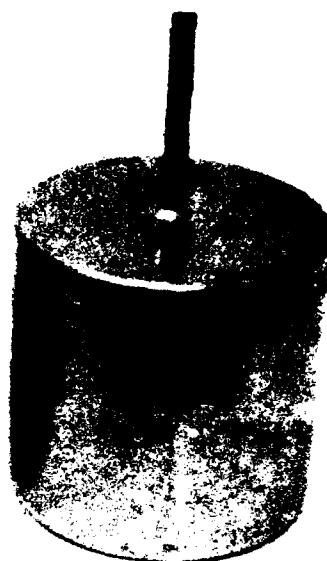
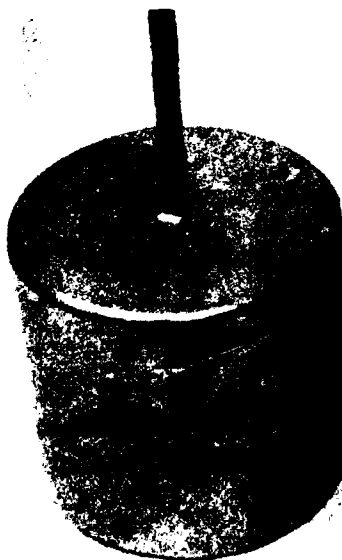
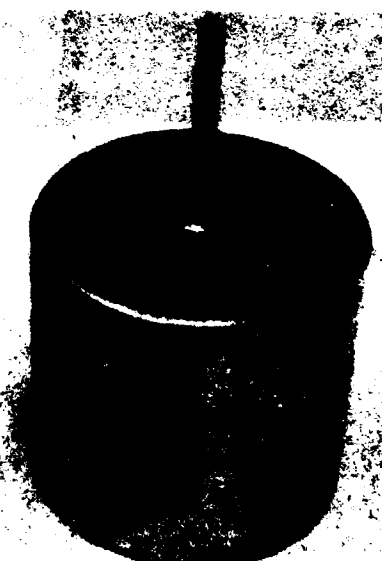
Figure 5. 6Al-4V Titanium Containers, Magnification 1/3X

All containers exhibited small isolated areas of titanium oxide from the heat treatment (aging) that were not removed during pickling. Examination of mottled areas at small magnifications revealed that these areas are primarily stain. Portions of these stained surfaces contained crater-like areas outlined by knifelike corrosion. Metallographic examination of sections taken through these areas revealed no detectable depth to the corrosion effects associated with the stained areas. Areas where stains appeared in the form of fingerprints, Figure 24, were given closer scrutiny to detect possible hot-salt stress corrosion effects, since the containers were aged in the contaminated condition. No defects attributable to water storage were found.

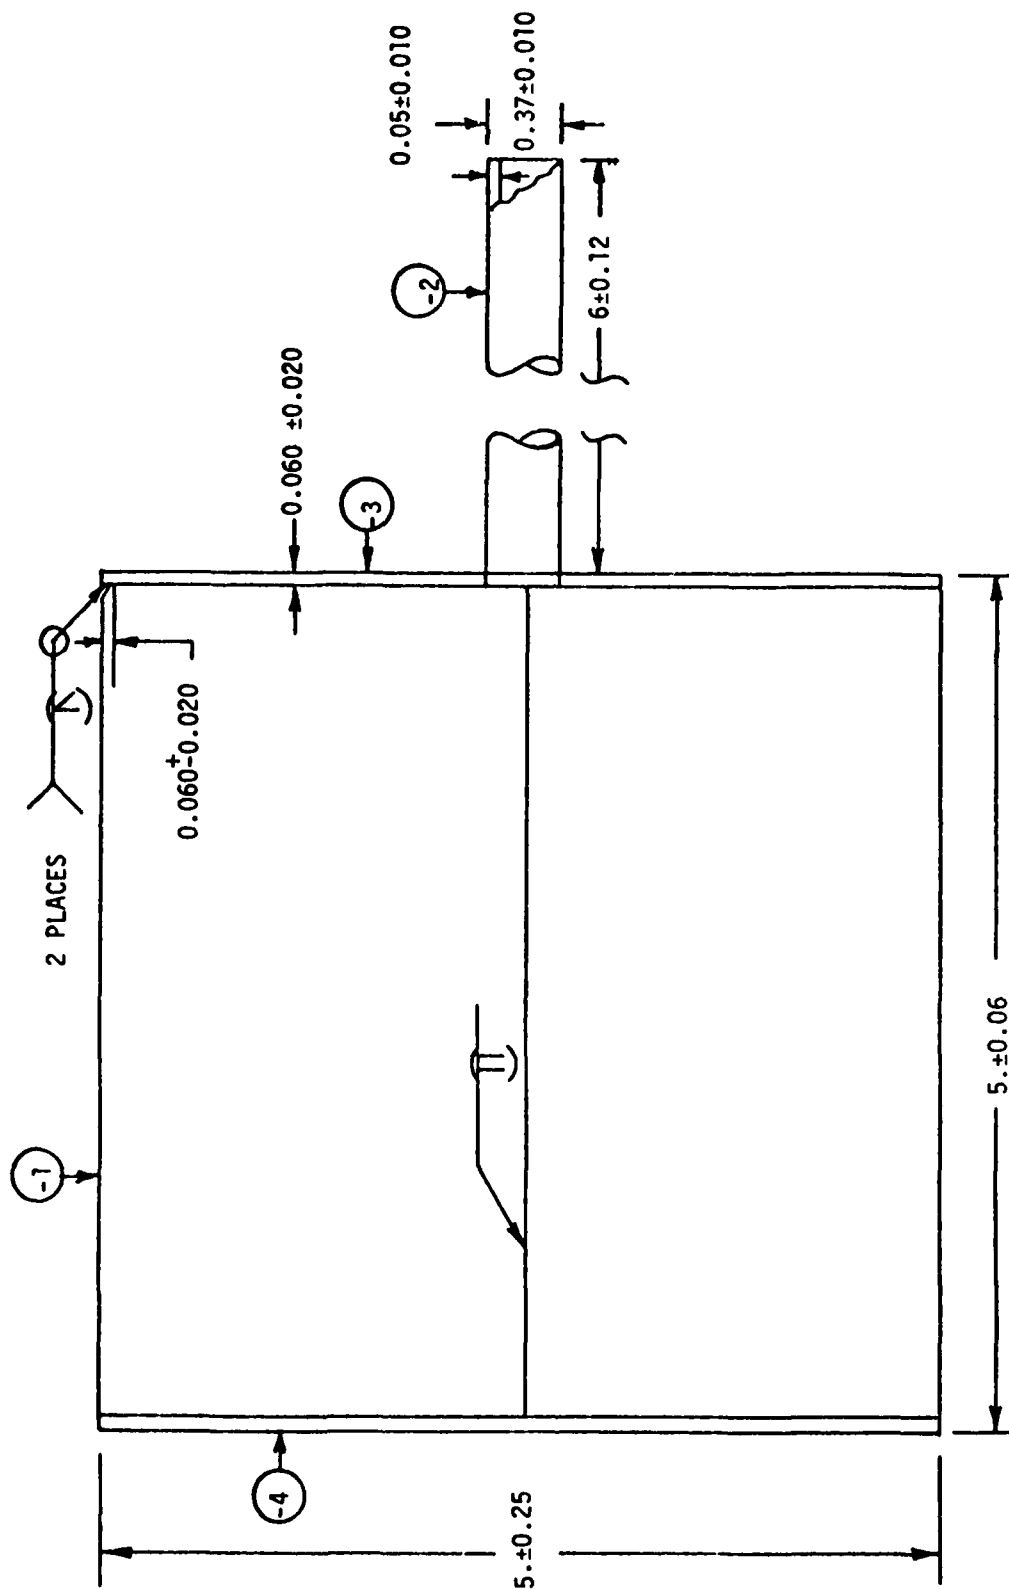
Figure A-1. Long Term Storage Container

- a. Fabricate -1 cylinder tube by rolling the sheared sheet stock into the desired diameter.
- b. Weld the longitudinal joint using the automatic GTA* welding process. Full weld penetration must be obtained using gas backup for the welds.
- c. Dye penetrant inspect welds then trim tubes to required length. No cracks allowed.
- d. Machine tube ends for weld joint preparation.
- e. Clean tubes and store in appropriate container while awaiting for next assembly.

- a. Blank tank heads to the desired diameter by punching or sawing and then machining.
- b. Machine weld joint preparation at outer edge as required.
- c. Drill the fill tube hole to mate with the fill tube.

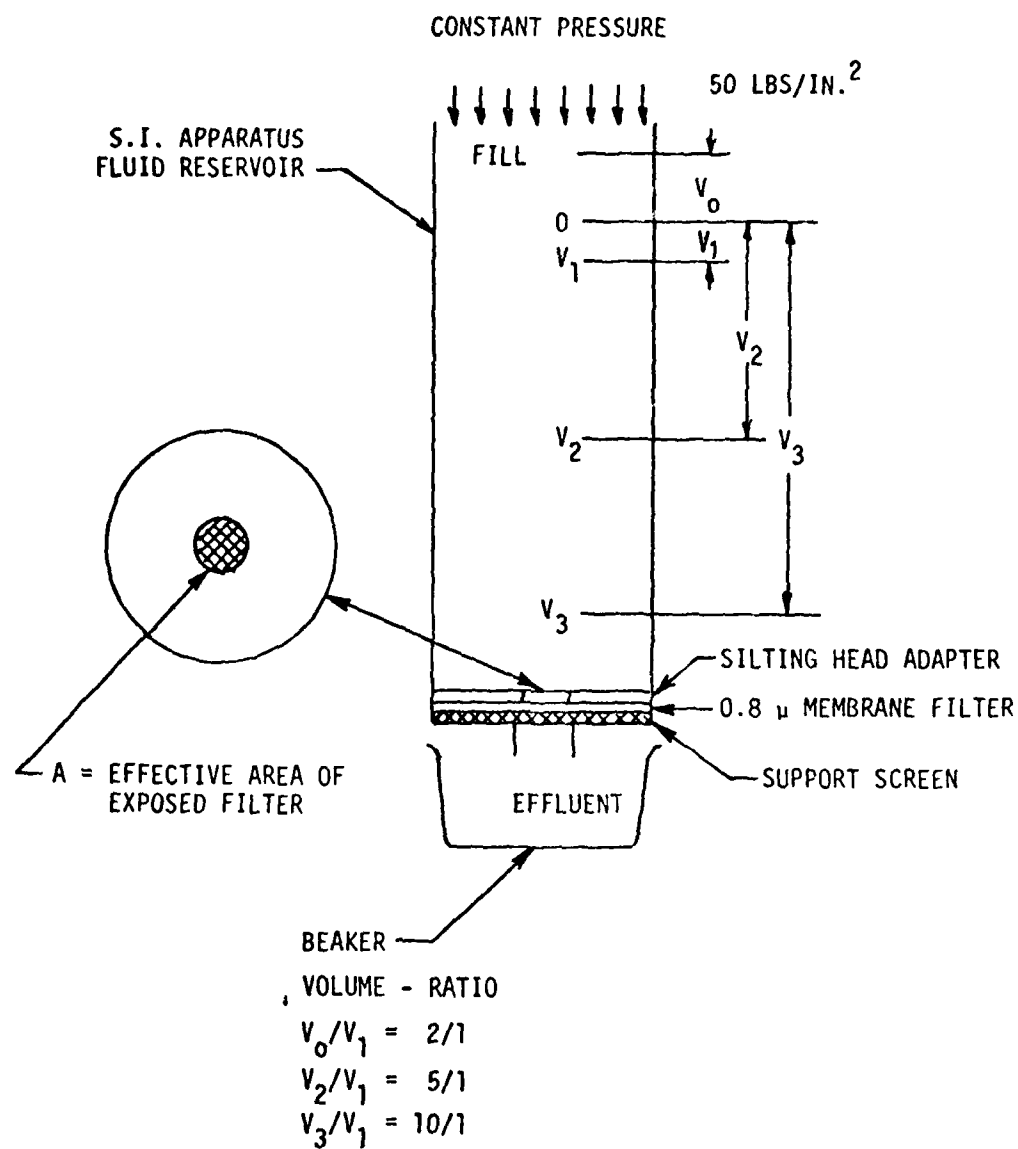
Figure B-1. Schematic of Silting Index Apparatus

The method determines the silting or clogging tendency of a fluid containing fine particles and gelatinous materials suspended in the fluid. The fluid is filtered through a membrane filter having a uniform pore size of 0.8 micron at a constant differential pressure. Particles larger than 5 microns form an open network above the filter and do not affect the clogging tendency; particles smaller than 5 microns tend to block the flow passages of the filter and cause a decay in the flow rate. The rate of flow decay is expressed in terms of a Silt Index value; the greater the value, the greater the clogging tendency. A schematic diagram of the apparatus is shown in Figure B-1.

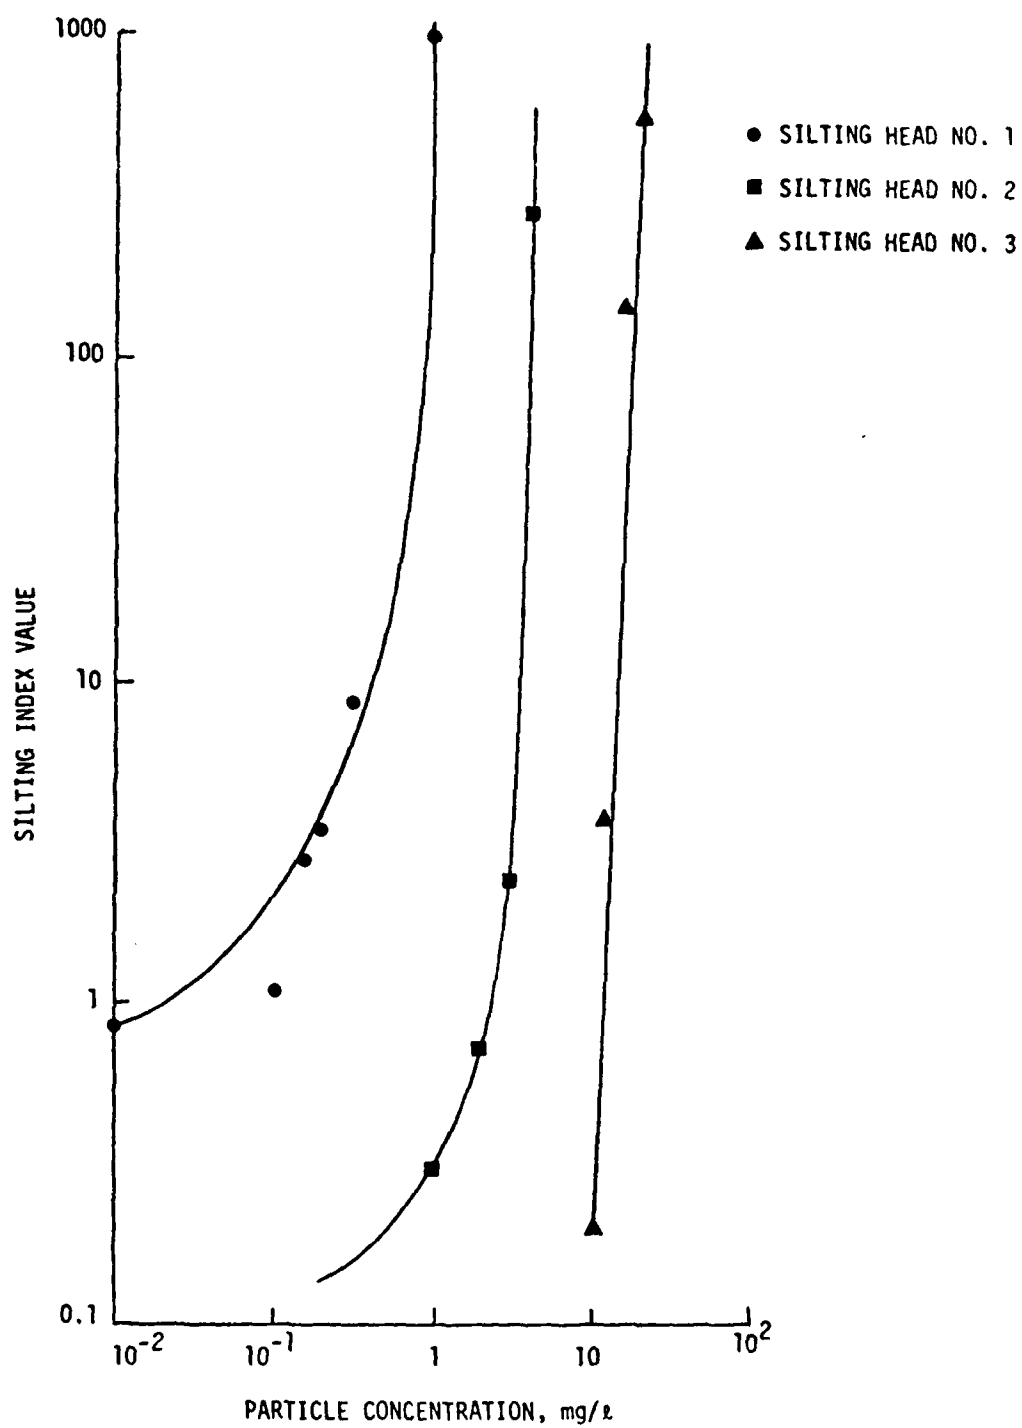
Figure B-3. Concentration Effect of 1.25 Micron Average Diameter Latex Particles on the Silting Index Values

densities of the particles are comparable. The significant item to note from the comparison of the data is that the Silting Index values are comparable at concentration levels that differ by at least one order of magnitude, the smaller particle producing the higher Silting Index value.
